Bad examples of Bicycle Rack installations

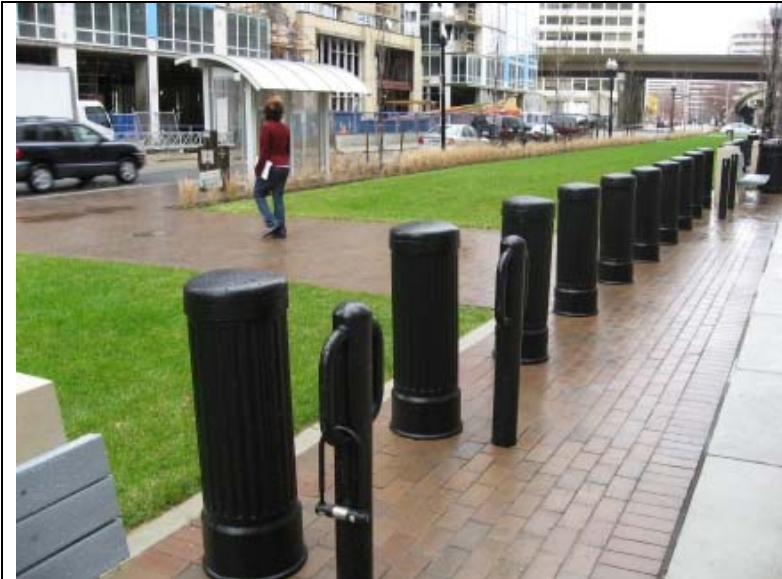
Example of “Post” type rack installed too close to a security bollard. There should be 30 to 36 inches of space between the rack and the bollard to allow two bikes to use this rack. As it is now, a bike cannot fit between the post and the bollard.

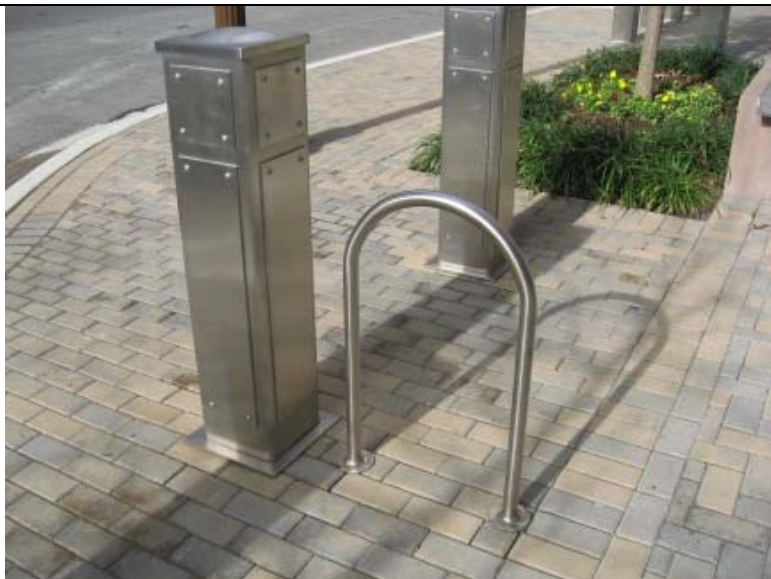
Example of Inverted U rack installed too close to a security bollard. There should be 24 to 36 inches of space between the rack and the bollard to allow for the wheels of the bike.

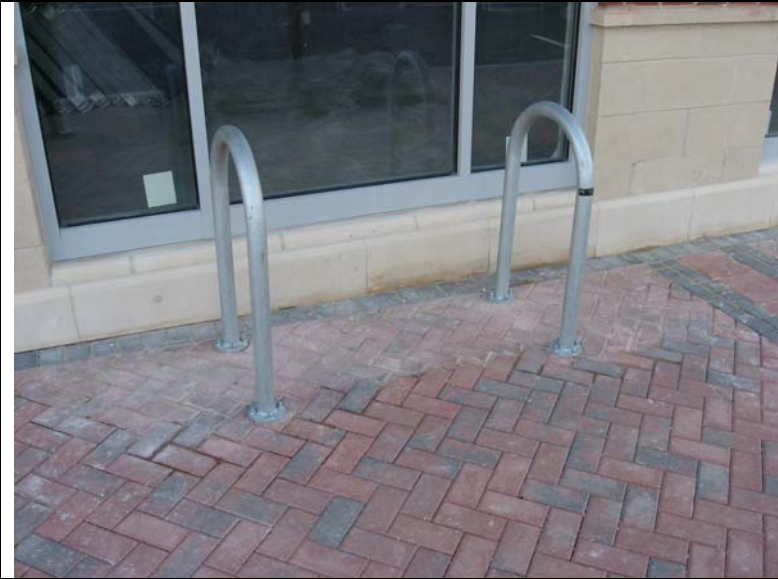
Example of Inverted U racks installed too close to the building. There should be 24 to 36 inches of space between the rack and the building to allow for the wheels of the bike.

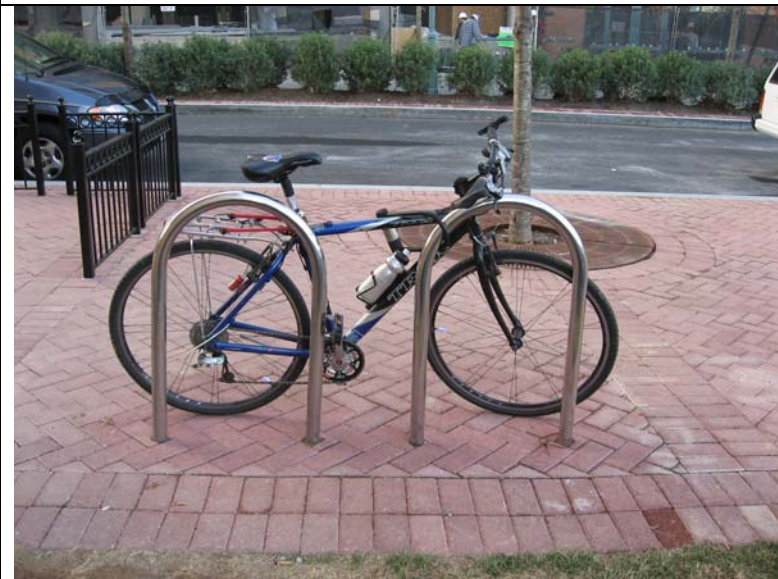
Example of Inverted U racks installed too close together. There should be 72 inches of space between the racks in this orientation to allow for the wheels of the bikes.

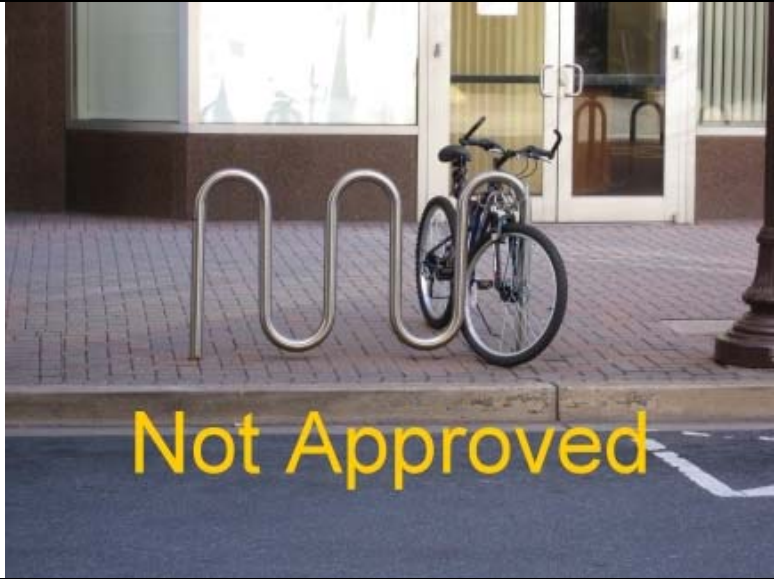
Arlington County does not approve the “Wave” bike rack design.

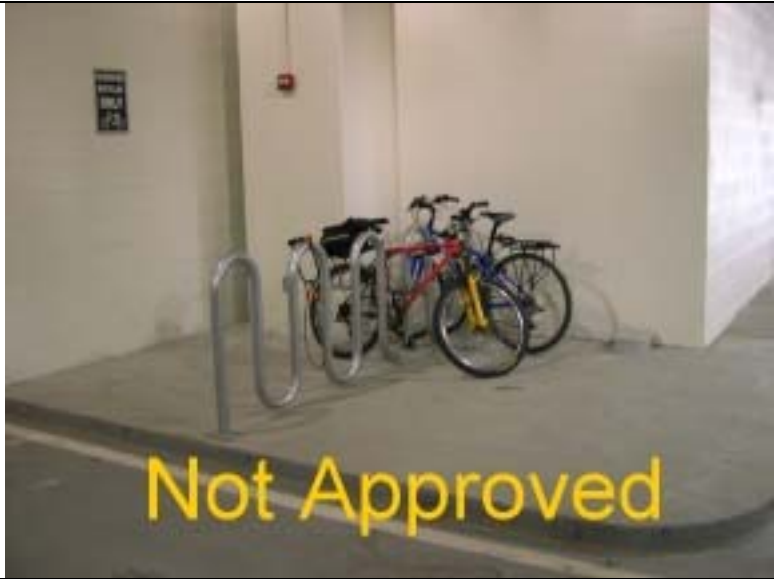
Arlington County does not approve the “Wave” bike rack design.
